Surface Water Quality Monitoring at the Gay Mine: Spring 2004

July 2004

Project No. 315-4127-003

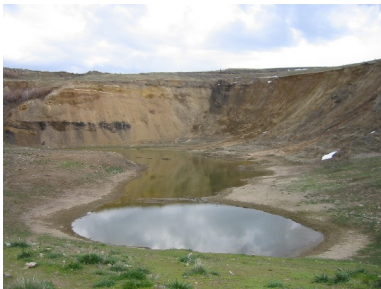
A12 Lake in A12 Pit - 013

In general, metal concentrations at most sampling locations were less than the corresponding water quality criterion or removal action level. Only Site 013 (A12 Lake in A12 Pit) was found to have a total recoverable selenium concentration (638 µg/L) that exceeded the corresponding removal action level for non-regulated surface water (210 µg/L).
